# The POWER of position

by Robert Kaplan

Predictive Maintenance Engineer  
Florida Power & Light  
St. Lucie Plant

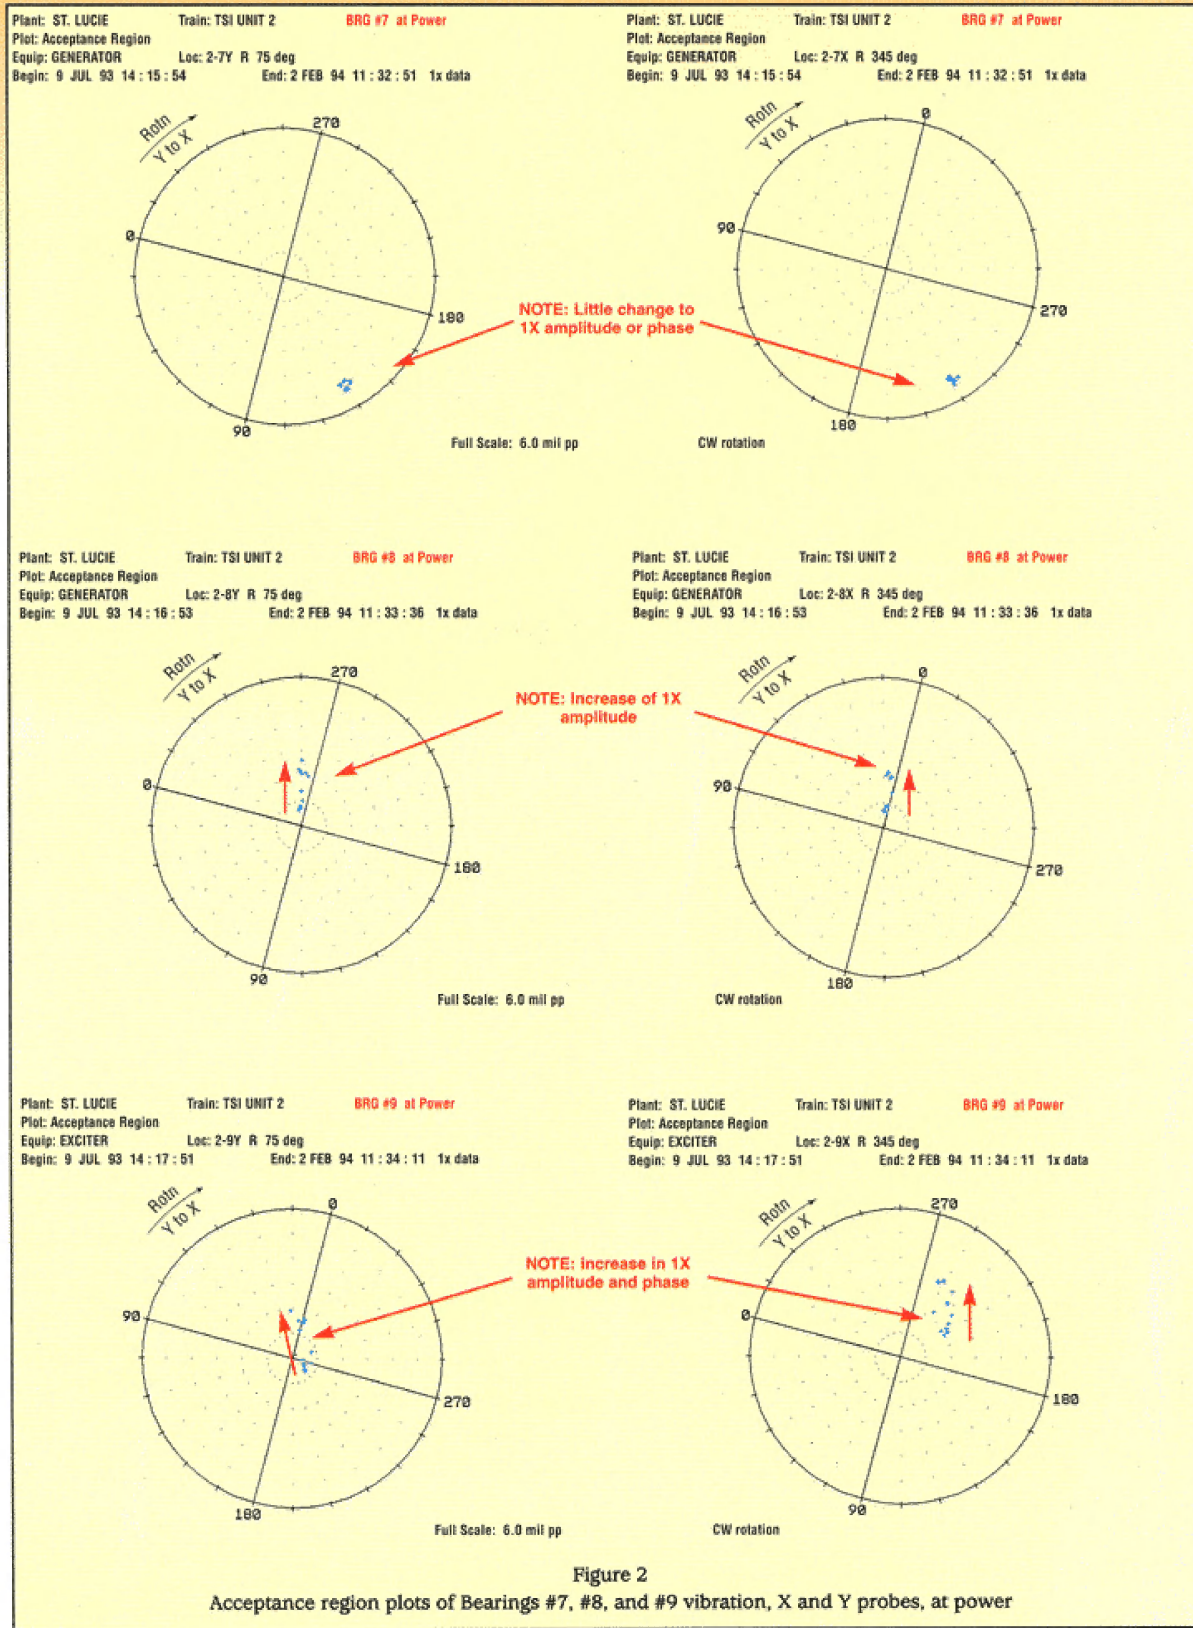
Figure 1

Bearings #7 and #8 support the generator rotor, and Bearings #8 and #9 support the exciter rotor. Bearing #9 also supports an overhung fan and permanent magnet generator (Figure 1). None of these bearings has an oil lift system.
